# Midwest Home Inspections,LLC

## CONFIDENTIAL INSPECTION REPORT

5/5/2020

**Furnished:** Yes  
**Structure Style:** Typical Ranch  
**Structure Orientation:** West

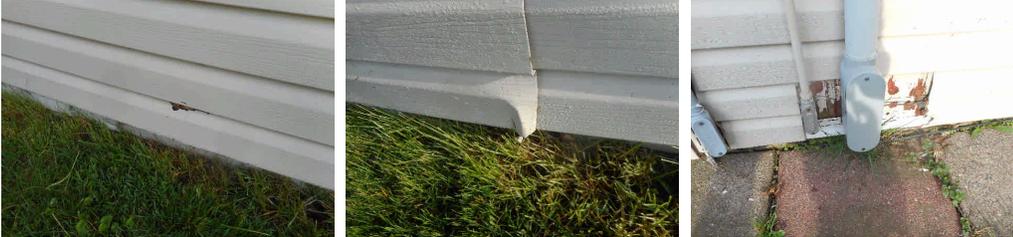
Portions of the siding are damaged, and should be evaluated and serviced as necessary. Also some separation above garage door.

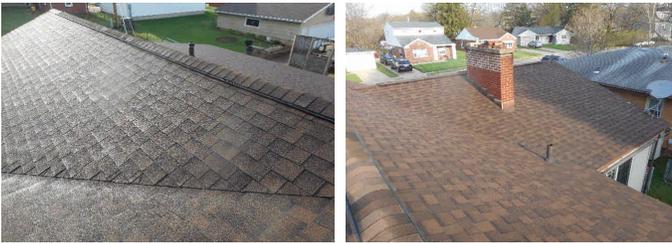
We evaluated the roof and its components by walking its surface.

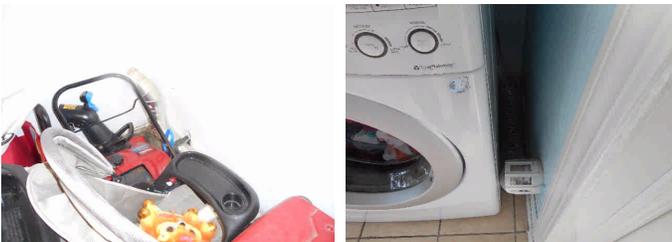
The dryer vents vertically in the garage. The lint trap must be kept clean, because trapped lint can rapidly turn into a fire hazard.

The dryer vent is a flexible type that traps lint more easily than a smooth metal type, which can compromise the performance of the dryer and can facilitate a fire, and you may wish to consider replacing it.
